Capsule Summary

Survey No.: T-1134

Name: Hidden Harbor

Maryland Historical Trust State Historic Sites Inventory Form

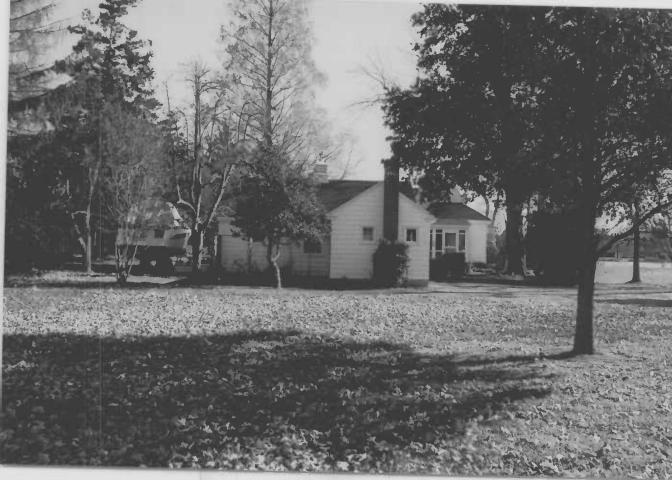
looking South al pourage

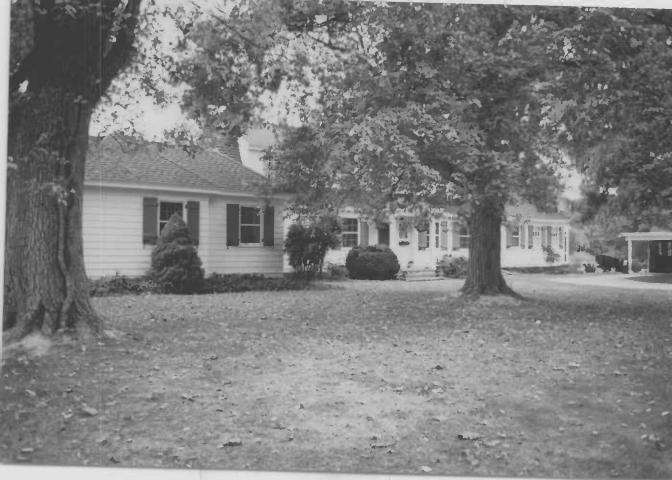
T-1134
Hidden Harbor
St. Michaels, Talbot Co MD
Rachel Mancin
October 21, 1998
negs MD SHPO

The main house on the property (House "A") is an early twentieth century, one-and-one-half-story Colonial Revival - Dutch Style frame building with one-story wings on the north and south elevations and an addition on the west elevation. The east and west elevations have continuous shed dormers within the gambreled roofline. Four paired six-over-six double hung windows covered with rolled awnings are within each dormer. An interior end chimney is located on the south gambrel end, and a second chimney is located at the center of the main block. Most of the windows on the first story appear to be six-over-six double hung windows with wood shutters. The central entrance on the east facade is covered by a hip roofed entry porch. Hipped roofs cover the south and north wings. A small screened porch is located on the north elevation of the north facade. The rear addition has been altered with the addition of three sliding glass doors on its west elevation. Each door is covered with a rolled awning. The exterior of the building is clad in wooden siding, and the roof is covered in asphalt shingles.

Main House, east elevation

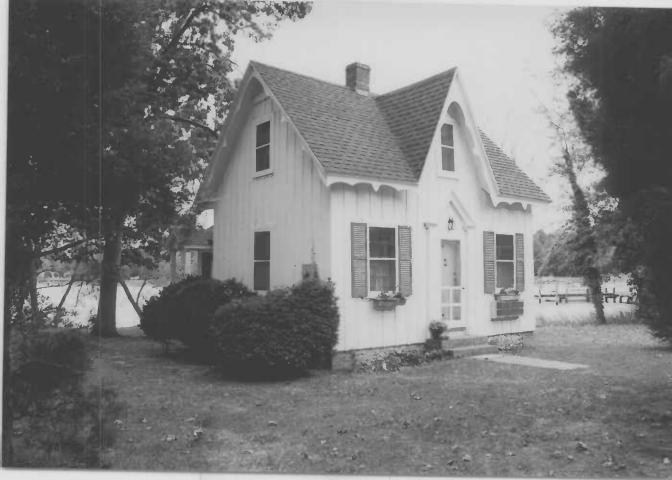
T-1134
Hidden Harbor
St. Michaels, Talbot G. MD
Rochel Mancin
October 21, 1998
neg - MDSHFO

The southeast of the main house is a mid-nineteenth century, three-bay, one-and-one-half-story, cross-gabled A.J. Downing Gothic Revival cottage with a rear single story ell (House "B"). The main block of the house rests on brick piers, and the rear ell on a brick wall foundation. A soft mortar mixed with whole shells fills in between the brick piers on the main block. The entire building is clad in vertical board and batten and is covered in asphalt shingles. The cross-gabled roof has a central interior chimney. A simple bargeboard trims the rafters on all the elevations of the building. The north facade has a central entrance covered by an open triangular pediment and flanked by six-over-six double hung window with shutters. A four-over-four double hung window is located within the cross-gable, above the entrance. The east elevation has four-over-four double hung windows on the first and second floors. A gabled entryway is located on the east elevation of the ell. The south elevation of the ell has a single six-over-six double hung window. The west elevation of the ell has an extended roofline and covers a screened-in porch. Access to the porch can be gained from a screen door on the exterior or a door on the interior of the porch leading into the house. A bay window with two six-over-six double hung windows is located on the first floor of the west elevation. On the second floor, above the bay window, is a single six-over-six double hung window.

Cottage, north elevation

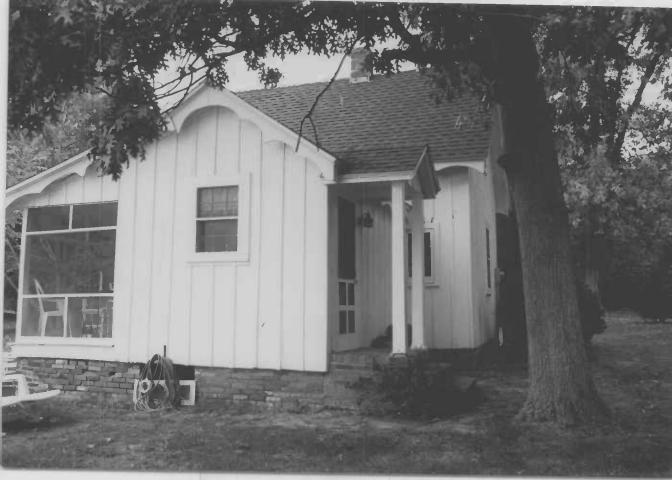
Hidden Harbor St. Michaels, Talbot Co MD Rachel Mancini October 21,1998 negs- MD SHPO

Cottage boleno NW

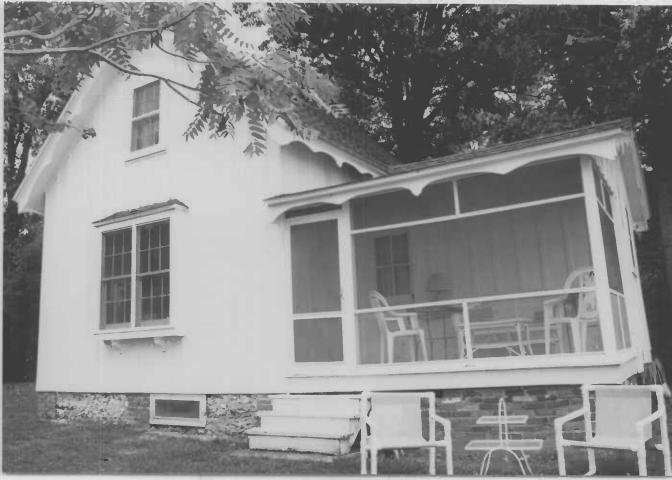
Hidden Harbor
St. Michaels, Talbot Co, MD
Rachel Moren
October 21, 1998
regs MD SHPO

Cottage west elevation

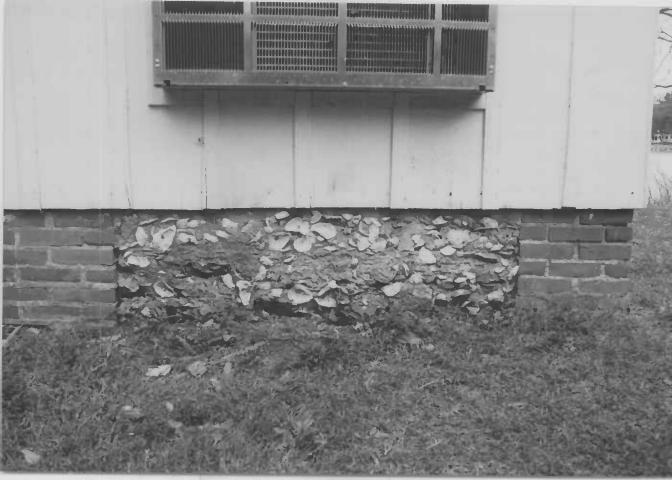
Hidden Harbor
St Michaels Taloot Co, MD
Rachel Mancini
October 21 1998
neds - MD STIFO

Cottage fill between piers

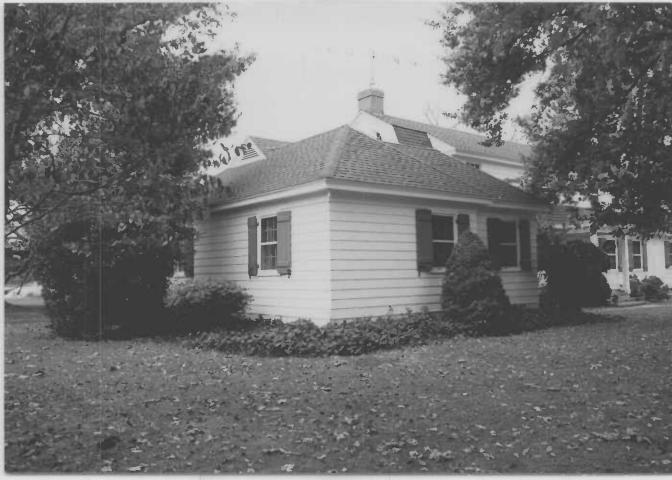
T-1134
Hidden Harbor
St. Michaels, Talket Co. MD
Rachel Marcin
October 21, 1998
neg's- MD SHPO

Main house, South elevation,

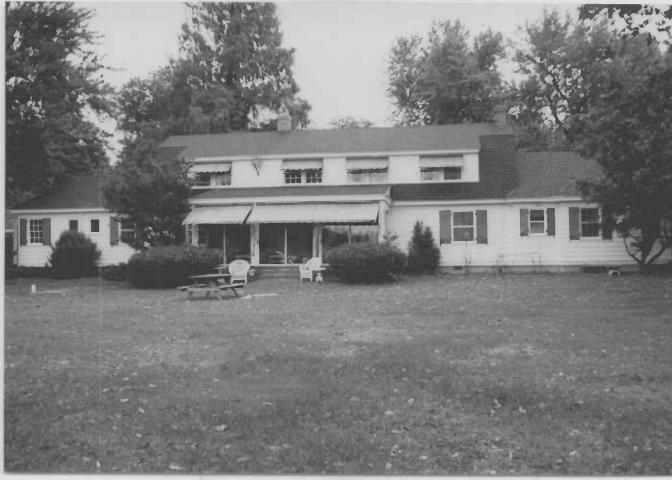
Hiden Harbor
St. Microels Talhot Co. MD
Facrel Morcin
October 21, 1993
negis - MD SHPO

Man house, west elevation

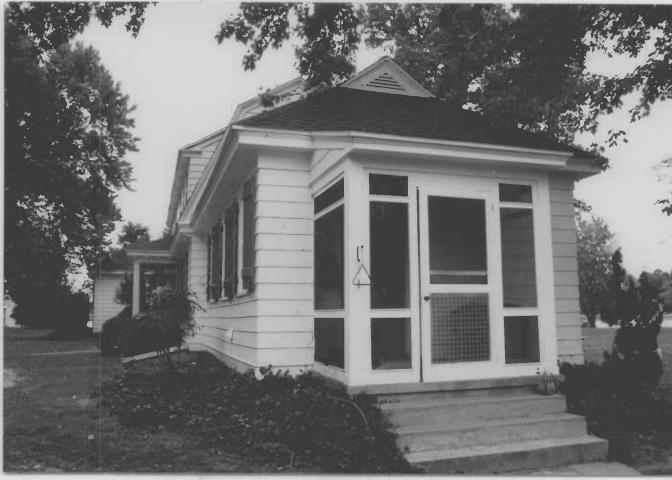
T-1134
Hidden Harbor
St Michaels, Talbot Co. MD
Rachel Mancin
October 21, 1998
neg's MD Stro

Main house, north elevation

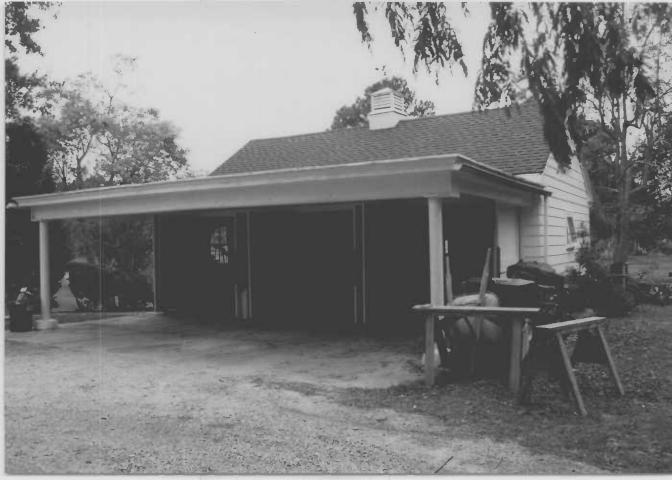
T-1134
Hodden Harbor
St. Michaels, Talbet Co., 11D
Rachel Manan
October 21, 1998
negs- Mil SHPG

Northeast of the main house is a three bay garage. The lateral gabled building has a shed-roofed addition on the south elevation covering the openings to the bays. A rear gable addition extends to the north. The building is clad in wood shingles, and the roof is covered in asphalt shingles.

Garage, looking NW
